# Manhole Inspection Summary

Manhole # S39CC\_041MH

Insp Date: **3/23/09 10:31 AM**

**Location** Address: **901 VALLEY CT**

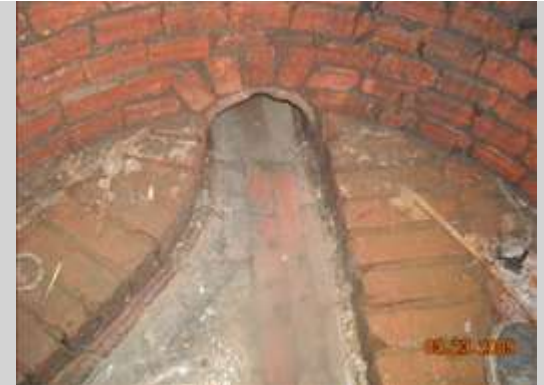
12 O'Clock Outflow

8 in. Circular Gravity Sewer  
Pipe Out @ 12 O'Clock

Pipe Height: **8.4** (in.) Rod and Bar (Angled)  
Pipe Material: **Clay** ☐ Pipe Lined  
Invert Depth: **10.85** (ft.) Flow Characteristics: **Fast**  
Deposits: ☒ None ☐ Mud ☐ Sludge ☐ Debris ☐ Grease  
Silt Depth: **0** (in.) Deposits Extent:  
Infiltration: **None** Pipe Seal Cond: **Sound**
